PTC BRINGUP. INSTALLED MOST COMPONENTS, EXCEPT IN POWER PATH SUCH AS MAIN INDUCTOR, MAIN SWITCH, SUPERCAPS, SOCKET FOR PICAXE. HOOKED UP 24V TO SOLAR INPUT.

03DEC15. ACS 723 - 40 AU 100 mV/A  
 - 20 AU 200 mV/A

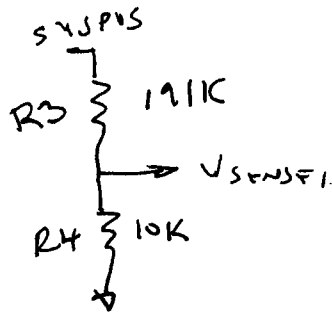
IN VOLT SENSE

$$V_{SENSE1} = \frac{10}{10+191} (V_{SYSPOS}) = 0.050 V_{SYSPOS}$$

$$= 0.102 V / COUNT$$

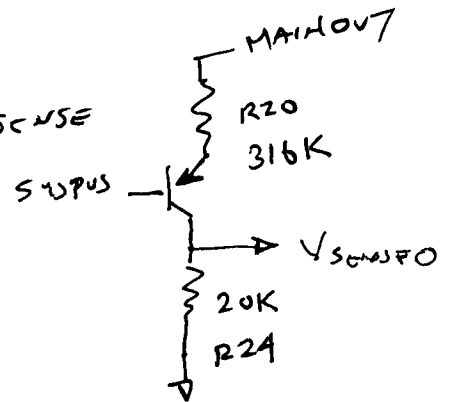
OUT VOLT SENSE

$$V_{SENSE0} = 20K \cdot \frac{(V_{MAINOUT} - 0.6)}{316K} = 0.063 (V_{MAINOUT} - 0.6)$$

ASSUME TRANSISTOR  $\beta = HIGH$

$$= 0.063 V_{MAINOUT} - 0.378V - 0.04V$$

$$= 0.081 V / COUNT$$

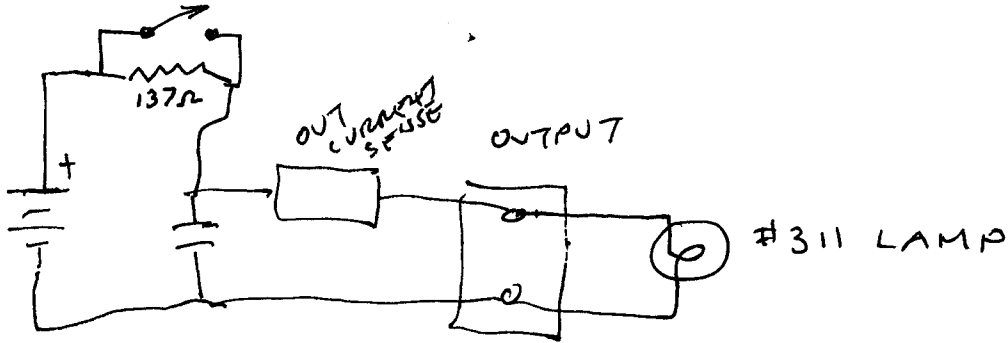
24.5V INPUT, USING 12V BATTERY OH OUTPUT AS FOLLOWS:

IN VOLT	IH CURRENT	MID CUR	OUT VOLT	OUT CUR	TEMP
OUTPUT NOT CONNECTED	24.5	107	102	1	104	225-230 (FLUATING)
OUTPUT CIRCUIT CONNECTED (SW OFF)	"	"	"	1	106	"
SW TURNED ON	"	"	"	154	121	"
SW TURNED OFF			1-5 SEC CAPACITOR CURRENT	6	106	
				2	105	
				1	106	
OUTPUT DISCONNECTED				1	104

IN VOLTAGE = 245 COUNTS = 24.99 V.

IN CURRENT = 107 NOMINAL, WHILE 0 CURRENT SENSORS READ 103.

WITH OUTPUT SWITCH FLIPPED, OUT CUR = 121 COUNTS.

OUT VOLT = 154 COUNTS x 81 mV / COUNT = 12.28 V REASONABLE

MID CURRENT W/ #311 LOAD TO STSPOS. - 128 COUNTS - 103 BASE

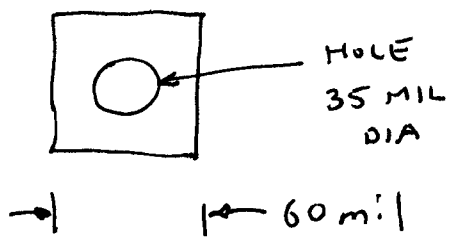
GATE WINDING HOLES ARE TOO SMALL FOR #20 WIRE,  
STRANDED.

#20 WIRE IS 32 MIL DIA, SO THEORETICALLY, IT SHOULD JUST FIT IF 35 MIL IS FINISHED HOLE SIZE. PART OF PROBLEM COULD BE MFG TOLERANCE, OR HOLE PLATING THICKER DUE TO 2oz COPPER, OR HASL SOLDER FINISH STICKING IN HOLES.

OH WAIT! I SEE THAT STRANDED #20 IS 38 MILS IN DIA IF IT'S 7/28 (7 STRANDS OF #28). MAYBE I CAN JUST FIND #20 SOLID.

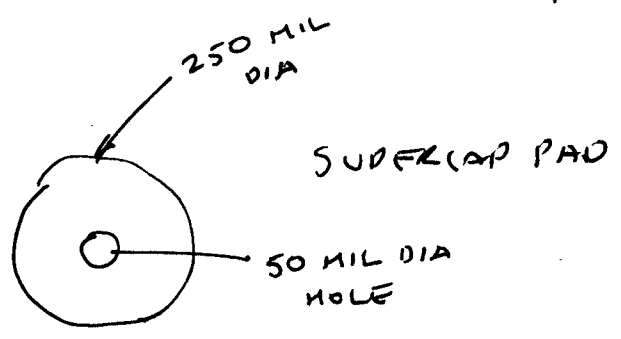
#20 WIRE FITS FINE IN THESE, BCAP LEAD DIAMETER IS 0.8mm = 32 MIL

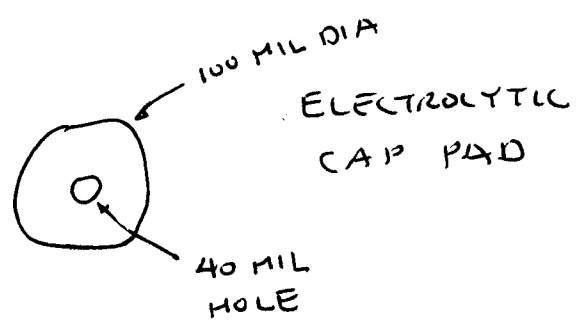
#20 FITS PERFECTLY.

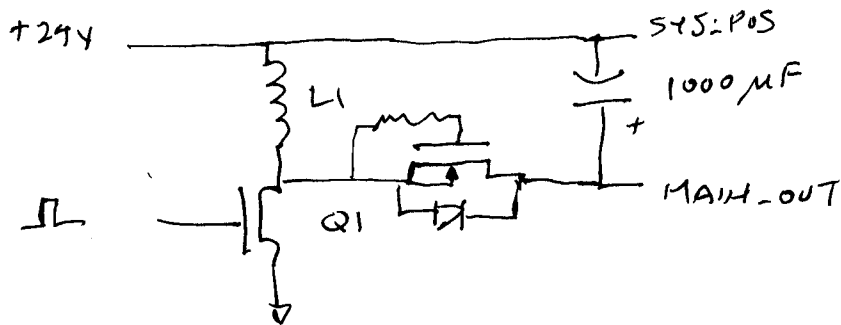
TRYING EXPERIMENT. Q1 INSTALLED, 30μH INDUCTOR TEMPORARILY  
INSTALLED, ONE 10 μS PULSE EACH TIME PUSHBUTTON IS PRESSED.

MAIN-OUT STARTS AT 0.01V

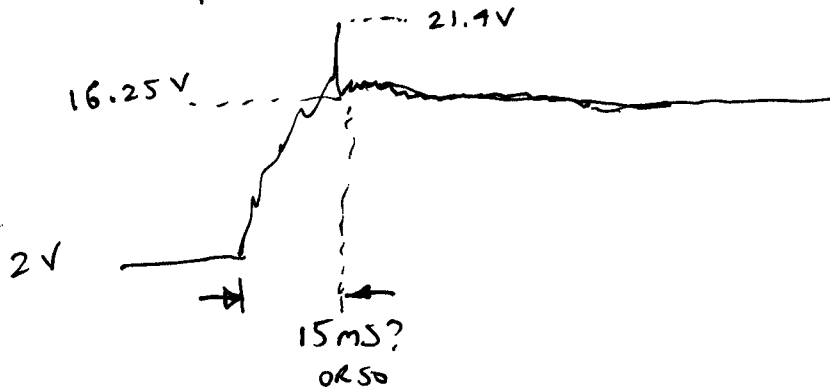
NOW CHECK OUTPUT VOLTAGE WITH COMPARATOR THRESHOLD SET  
AT 1.00 VOLT, OUTPUT

WILL SET NEW THRESHOLD AT <sup>1.50</sup>~~2.00~~ VOLTS, FOR APPROX 24 VOLT  
OUTPUT LIMIT. IN SERVICE, LIMIT WILL BE HIGHER, COMPARATOR USED  
AS EMERGENCY SHUTDOWN ONLY. IN SERVICE, LIMIT WILL BE  
MAYBE 2.1 VOLTS, THRESHOLD.  
WITH THRESHOLD SET AT 1.502 V, SEE 24.2 VOLTS ON OUTPUT.
